# Elementary, My Dear Watson...

*By Neil McManus, CIH, ROH, CSP*

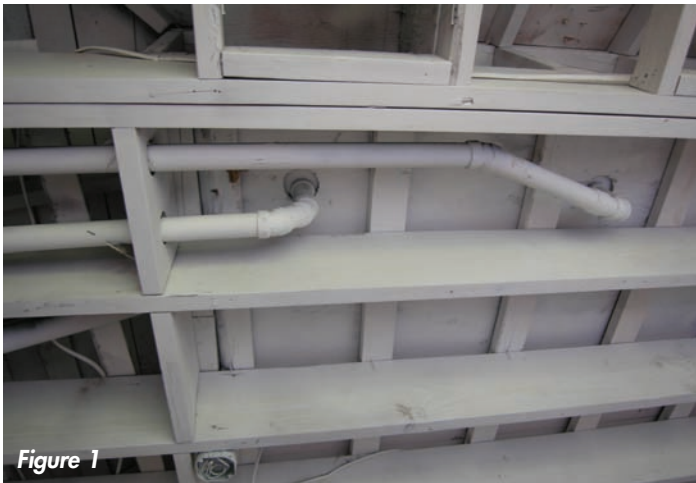
Figure 1

**Figure 1. Drain fittings on the bottom of the balcony. Note the glued fittings.**

contained fittings that were glued together. The horizontal drains contained a flanged metal fitting normally used in drains on tar and gravel roofs. In this case, the metal drain pipe of the fitting fitted inside the plastic drain pipe in a manner similar to what would occur in the metal tubing used in a roof drainage system.

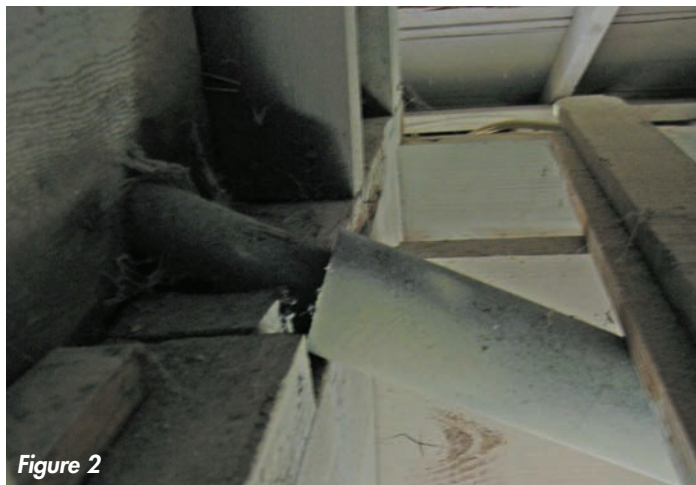
Figure 2

**Figure 2. Inserted drain fitting. This picture shows the metal drain fitting inserted into the plastic drain pipe. The fitting and the pipe were not sealed together. Blockage of water flow in the drain pipe caused by an ice dam led to backflow into the ceiling cavity.**

The key to the situation was the manner of inserting the piping of the metal flange into the plastic drain pipe. Insertion of an improvised wire “fish” demonstrated that the interface between the plastic and the metal was not

sealed. Winter conditions in Vancouver can change rapidly from snow to rain to freeze to thaw to freeze, and so on. Under such conditions, freeze-up in drain piping of small diameter located in an isolated and unheated void space is a realistic possibility. Freeze-up readily occurs in drain pipes of small diameter that leads from roofs. Freeze-up in the drain pipe followed by rain following the unusual and severe weather that occurred during the period would lead to back-up in the drain pipe and overflow into the ceiling space and the damage that subsequently occurred.

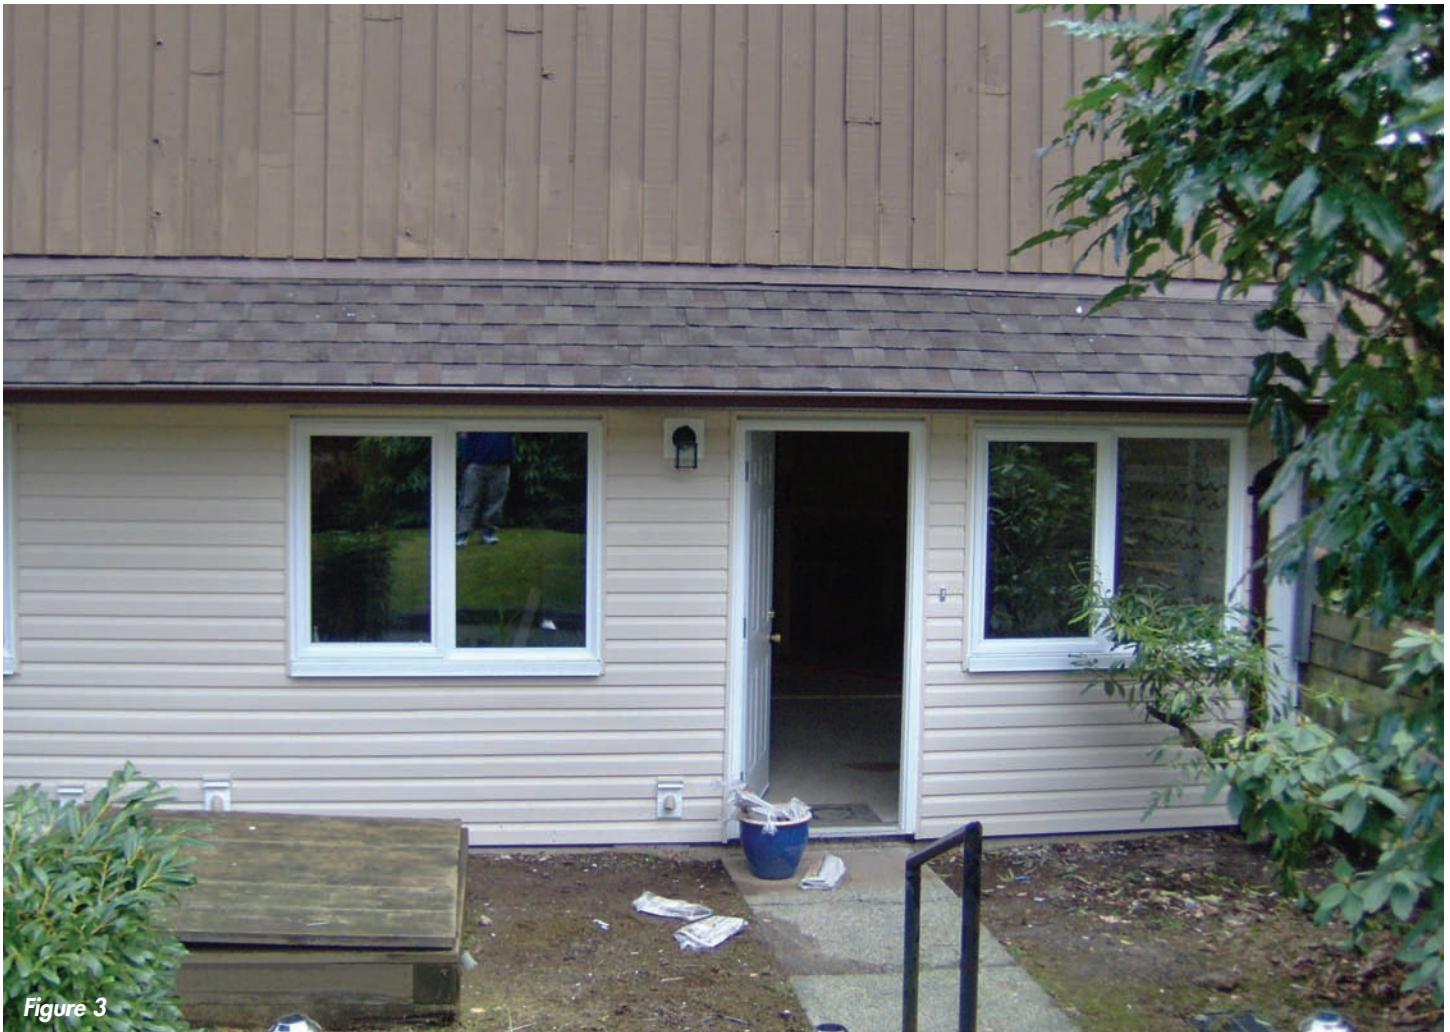
Figure 3

This situation concerned a wetting episode of prolonged duration along the west exterior wall in a townhouse estimated to be 35 to 40 years old. The wetting episode resulted from a problem associated with the siding. The exterior of this building consists of wooden planks applied vertically with a thin strip of wood covering the seams. Over time, the planks shrank in length, warped and otherwise deteriorated. This situation led to the opening of gaps at the ends and sides of individual planks, thus creating pathways for entry of moisture into the building envelope.

**Figure 3. Exterior walls (outside) following replacement of siding. This picture shows the original siding and the new siding installed by the building envelope contractor. Note the vertical orientation of the planks of original siding and the gaps at the end of the planks caused by shrinkage due to drying of the lumber. Warping can cause separation of one plank from another. These effects of aging create paths for leakage of moisture and liquid water.**

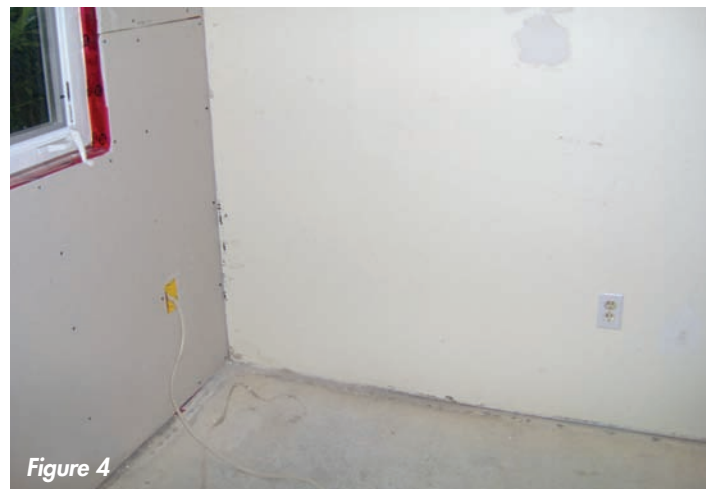
Figure 4

**Figure 4. Exterior wall (inside). This picture shows the drywall newly applied by the building envelope contractor and an existing interior wall. Minor gaps and penetrations in the drywall presumably provided the path for entry of *Stachybotrys* spores from the exterior wall cavities.**

The newly applied drywall encountered during the visit provided no hint for the findings determined in the air samples. Normally, when visible, *Stachybotrys* would be observable as black patches. The preferred food source for *Stachybotrys* is cellulose, as found in wood, and of course, paper. These observations presumably meant that the *Stachybotrys* was present in the wall cavities.

The answer to the second question presumably reflected the status of the wall cavities on outer walls of the building and the nature of the ventilation. These walls were subject to wind pressure and the negative pressure created by the negative air mover and bathroom fan. The differential pressure created the motive force for airflow inward through leakage paths in the building envelope. The inward air flow created the turbulence needed to aerosolize spores contained in the wall cavities. Long-term wetting of building materials in the exterior wall cavities created the growth opportunity for *Stachybotrys*.

What was the source of the *Stachybotrys* spores and why were they airborne in such high concentration? To this point, the exact location remains unknown. The building envelope contractor returned to this dwelling and removed the drywall on exterior walls to the 4-foot level and spray-applied a paint-like coating to the exposed wall cavity. (This activity occurred independently from actions of the building restoration company and the author.) Subsequent air sampling under similar conditions indicated the absence of *Stachybotrys* spores in air inside the dwelling.

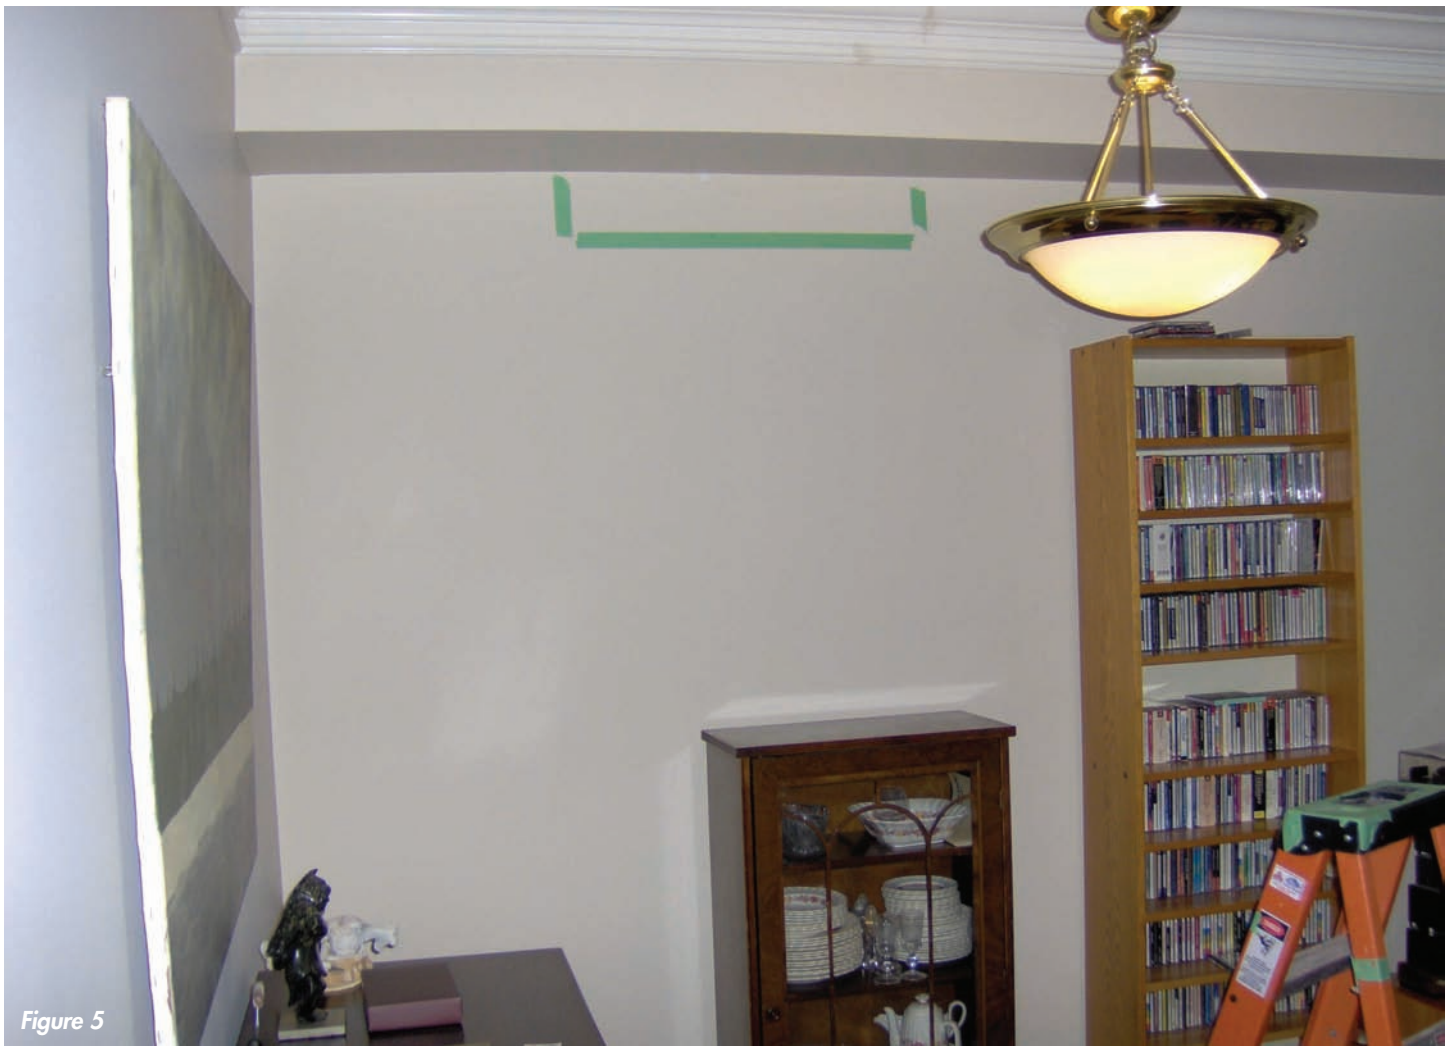
Figure 5

**Figure 5. Wall showing extent of migration of water from the ceiling. Surface sampling indicated mold contamination in the area wetted located above the tape and lack of contamination in areas of the wall located below the tape that had not experienced wetting.**

During exploratory work involving the wetted wall, the restoration company discovered growth of mold at the interface between the two panels of drywall. They left the walls intact, save for the holes created by exploratory activity.

Samples obtained at different locations on surfaces known to have been wetted contained *Aspergillus/Penicillium* spores. These spores were not present on a surface known not to have been wetted and immediately below one known to have been wetted. (*Aspergillus* and *Penicillium* spores are similar in appearance and difficult to differentiate. Labs often report them together.) These samples also indicated the absence or very low presence of mycelial fragments. Mycelial fragments indicate active growth, as would occur in wet or damp materials following a wetting event.
