# CO<sub>2</sub> BLASTING

## The Remediation Tool of the Future

By Neil McManus, CIH, ROH, CSP

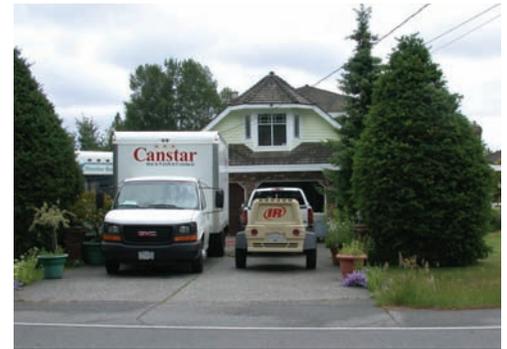
**Figure 1. Set-up of the compressor. Note that the location is well-removed from the front of the house to prevent entry of exhaust gases.**

A diesel-powered air compressor was used to supply motive power to the delivery system (Figure 1). The CO<sub>2</sub> pellets were contained in a large tub (Figure 2). These were transferred to the delivery equipment using a plastic scoop. The delivery equipment contains an auger system to force the pellets into the airstream (Figure 3). This work occurred near the beginning of June. Despite the presence of overcast conditions and light rain, sublimation was actively occurring in the storage chest, in the delivery equipment and delivery lines. Production of gaseous carbon dioxide can displace the normal atmosphere in any low-lying area.

- *The compressor:* The compressor used in this job produces 175 ft<sup>3</sup>/min at 125 lb/in<sup>2</sup>. This corresponds to a supply ventilation rate of 1450 ft<sup>3</sup>/min at normal pressure delivered into the work zone near the location of blasting. This air dilutes the carbon dioxide, but also competes with the negative air mover in its attempt to maintain the building under negative pressure. If this supply of air is not factored into calculations to determine required capacity of negative air movers, then it is quite possible that the enclosure could go to positive pressure during the work.

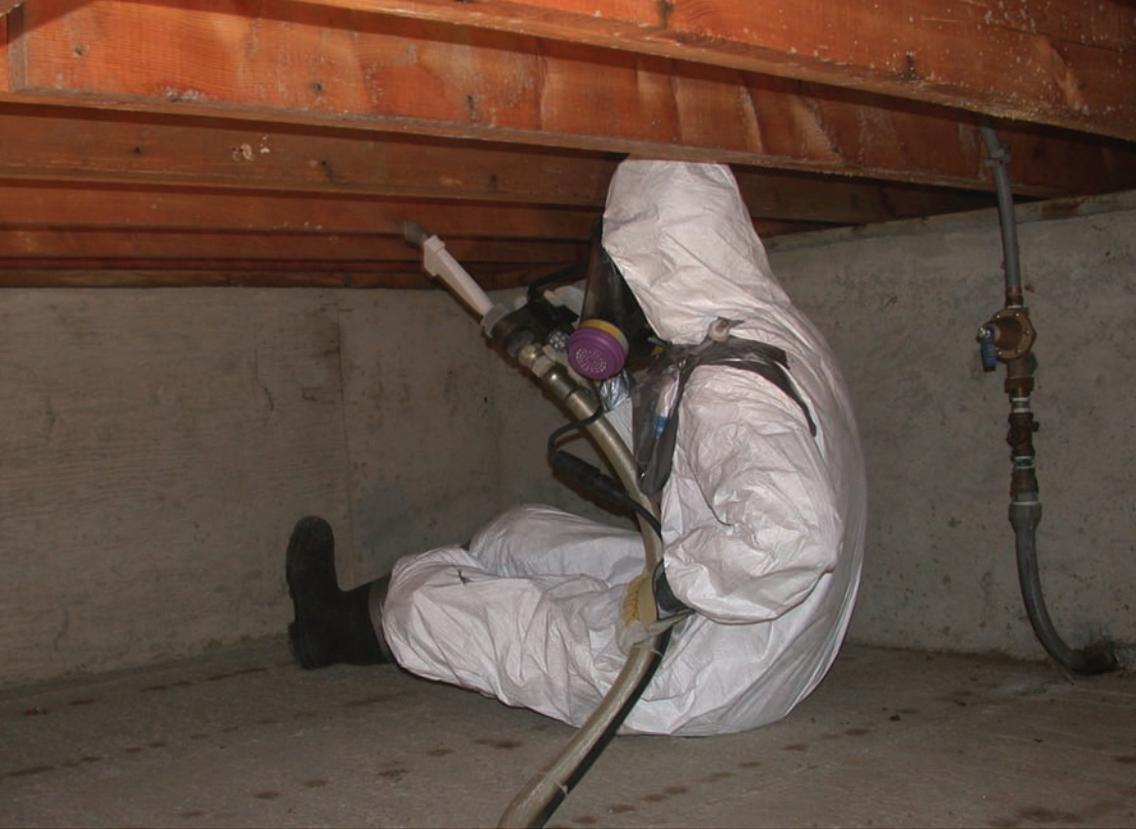
*This picture depicts the work posture in the crawlspace. The speed of the work, compared to sanding, compensates somewhat for the lack of ideal work position. Note the position of the probe of the four-gas tester on the shoulder of the worker.*

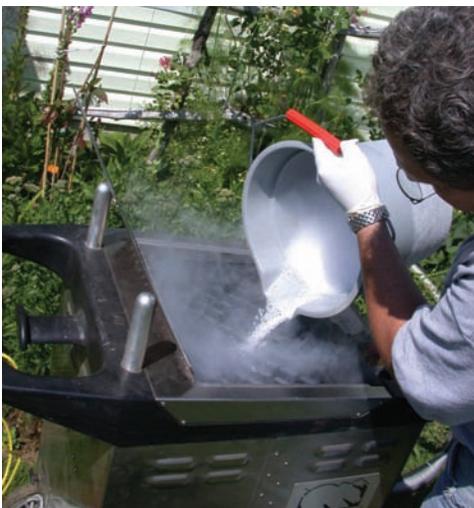
**Figure 2. Dry ice handling.** Sublimation leading to production of carbon dioxide gas poses the ever-present risk of oxygen deficiency, especially in low-lying areas.

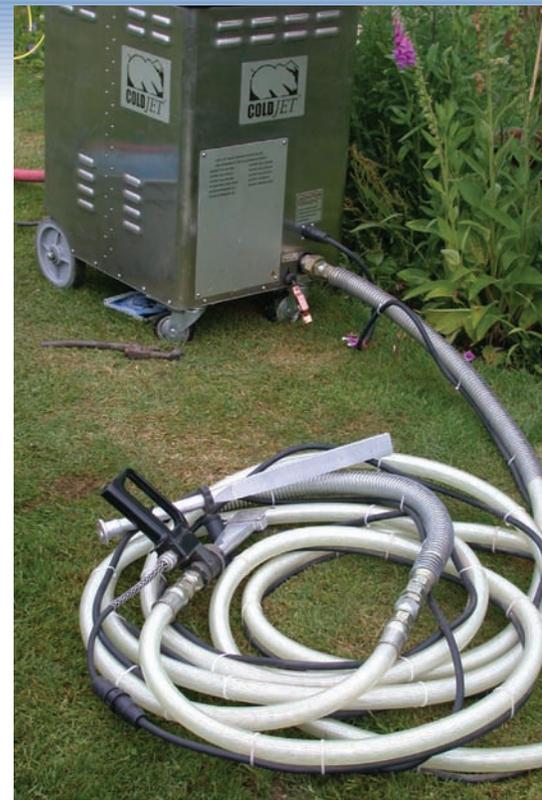
**Figure 3. Dry ice auguring machine. Note the clip for attaching to electrical ground. Carbon dioxide pellets transported in compressed air create serious risk of electrostatic discharge. This discharge has sufficient energy to ignite flammable mixtures.**

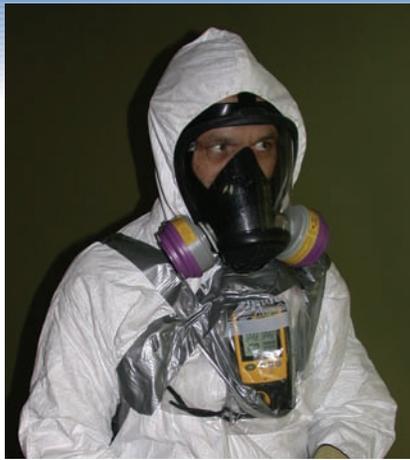
**Figure 4. Worker wearing four-gas tester. Continuous monitoring is essential during this work. Note that the oxygen alarm is set to 20.5 to prevent overexposure to carbon dioxide, as well as oxygen deficiency.**

As part of the hazard assessment and procedure, and by regulatory requirement, the worker entering the space was required to wear a four-gas testing instrument (oxygen, ignitables, carbon monoxide and hydrogen sulfide) containing a built-in pump (Figure 4). The built-in pump enabled the instrument to be protected from damage, to actively sample the air breathed by the worker, and to be close enough to be heard in the event that the alarm sounded. (Only the oxygen and carbon monoxide sensors were required during this work.) The alarm for low level of oxygen was set to 20.5 percent. (Note that the factory set-point for the oxygen alarm on these instruments typically is 19.5 percent. This must be adjusted upward to offer protection against CO<sub>2</sub>.)
